# **INDOOR AIR QUALITY ASSESSMENT**

**Manchester-Essex Regional Middle High School  
36 Lincoln Street  
Manchester, MA 01944**

Prepared by:  
Massachusetts Department of Public Health  
Center for Environmental Health  
Bureau of Environmental Health Assessment  
Emergency Response/Indoor Air Quality Program  
February 2005

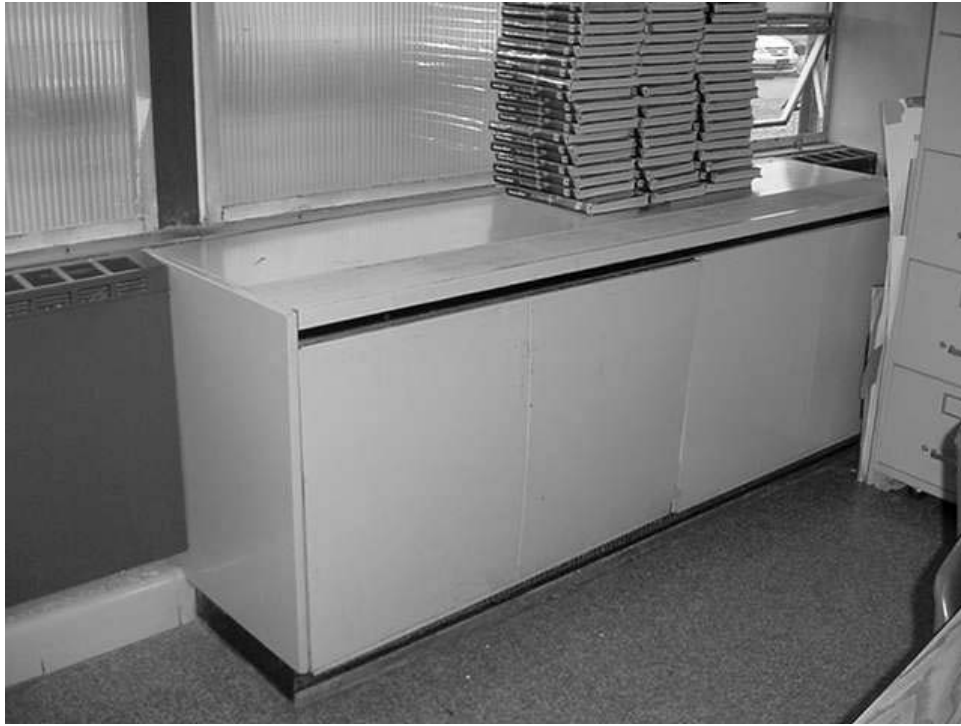
**Picture 1**

Fresh air in most classrooms is supplied by unit ventilators (univent) that were installed during construction of the classrooms (Picture 1). A univent draws air from outdoors through a fresh air intake located on the exterior wall of the building and returns air through an air intake located at the base of the unit ([Figure 1](#)). Fresh and return air are mixed, filtered, heated and provided to classrooms through an air diffuser located in the top of the unit. Obstructions to airflow, such as desks and other items located in front of univents were

observed in some areas. Many univents were not operating or were operating weakly at the time of the assessment. To function as designed, univents must remain free of obstructions and be allowed to operate.

**Classroom univent**

1. Examine each univent for function. Operate univents while classrooms are occupied. Check fresh air intakes for repair and increase the percentage of fresh air intake if necessary.

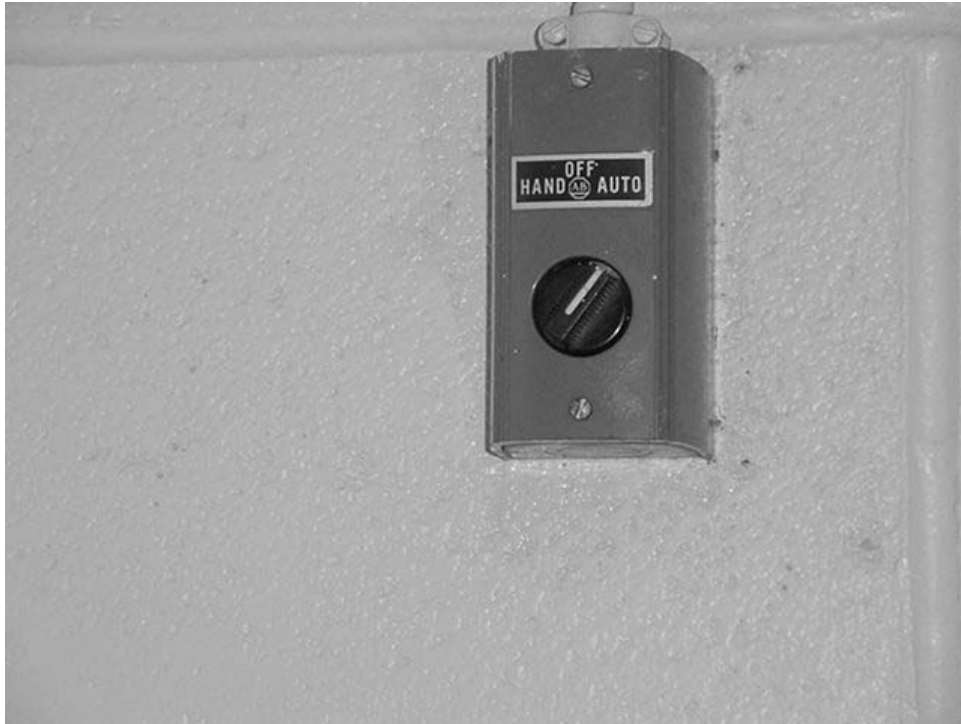
**Picture 2**

Fresh air is mechanically supplied to audio/visual wing rooms, various offices, as well as second floor classrooms and library via ceiling-mounted diffusers ducted to air-handling units (AHUs). The thermostat-controlled system is the primary source of fresh air supply. The thermostat can be set to either “auto” or “on” (Picture 2). In one area, the thermostat was found in the "auto" position, which deactivates the HVAC system once the pre-set temperature on the thermostat is reached (Table 1). As a result, the AHU was deactivated and fresh air circulation was limited. Occupants in the art/pottery room reported that the AHU servicing this room had been deactivated. In order to dilute odors and particulates produced in the art/pottery room area, the AHU must be activated and allowed to operate as designed.

**HVAC control unit set to ‘auto’**

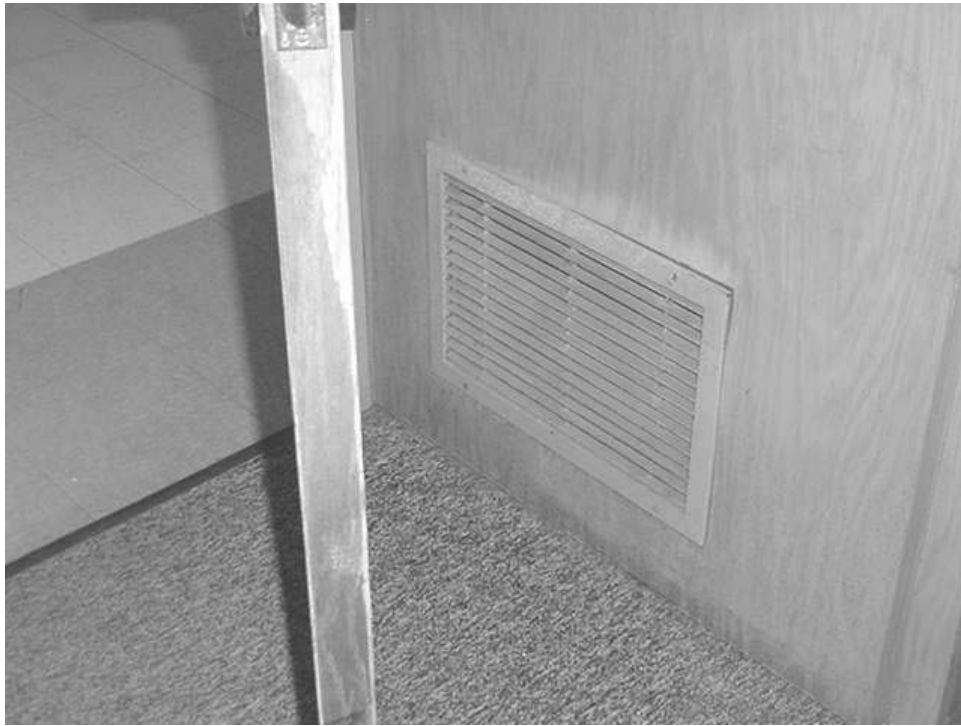
**Picture 3**

Mechanical exhaust ventilation consists of ceiling-or wall-mounted exhaust vents (Picture 3), which are ducted to rooftop motors. At the time of the assessment, these vents were either off or operating weakly throughout the building. Most classroom exhaust vents are located on walls perpendicular to the hall doorway. When hall doors are open, the exhaust vent is blocked, thereby preventing the draw of classroom air. As with univents, exhaust vents must be allowed to operate and remain free of obstructions.

**Mechanical classroom exhaust vent, note location and proximity to door**

2. Examine exhaust vents for function and make repairs as necessary.
3. Operate all ventilation systems that are operable throughout the building (e.g., gym, auditorium, classrooms) continuously during periods of school occupancy independent of thermostat control to maximize air exchange.

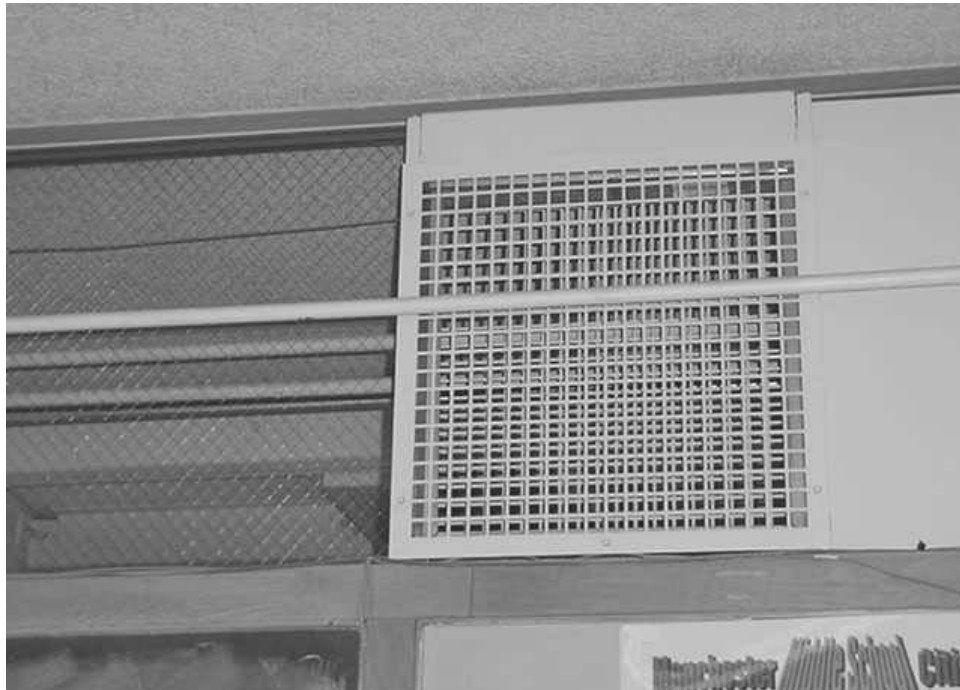
**Picture 4**

In addition to mechanical exhaust, classrooms in the middle school and high school math/science wings have passive exhaust vents in hallway walls (Picture 4). The likely function of these vents is to remove odors and/or smoke produced by chemistry/biology experiments. This design allows air to pass through a classroom and into the hallway. An exhaust vent is located in the hallway (Picture 5). The vent is ducted to a motorized rooftop

**Passive classroom exhaust vent**

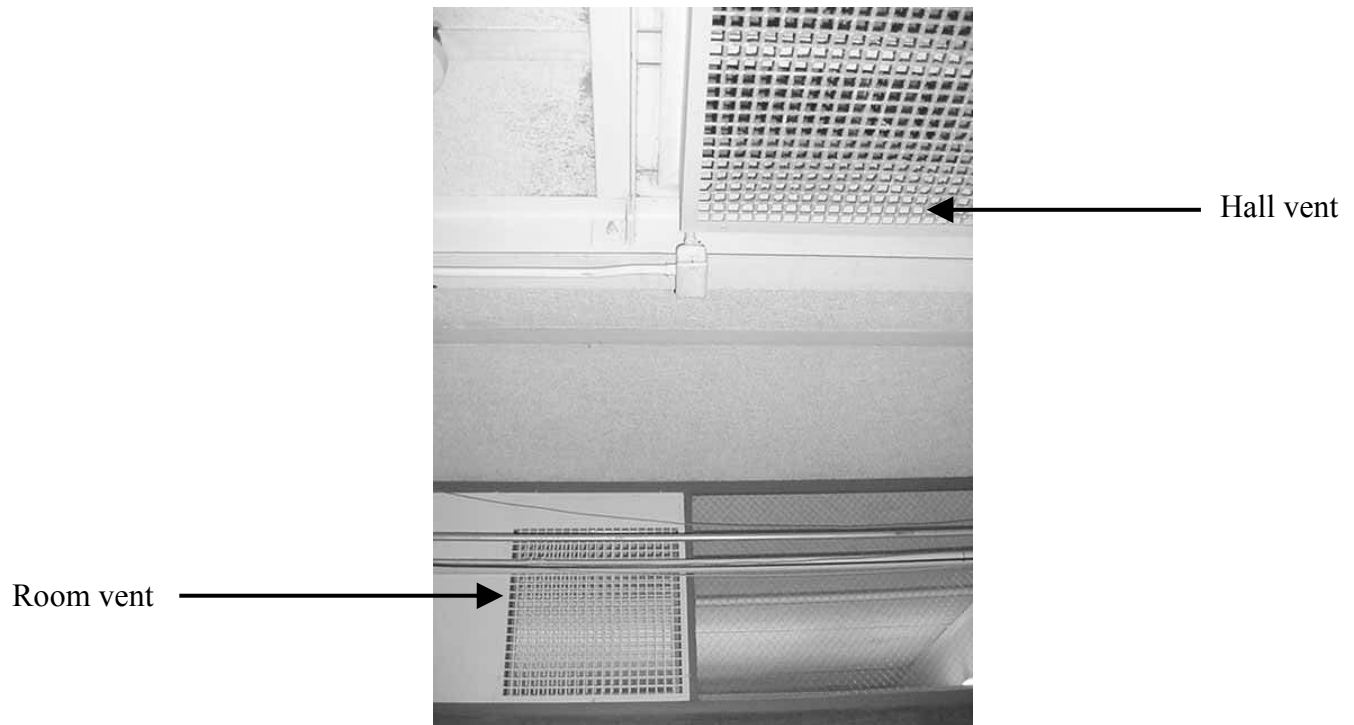
**Picture 5**

fan and aides draw of classroom air into the hallway. Some hallway exhaust vents appeared to be closed at the time of the assessment.

**Location of classroom vent to hallway vent**

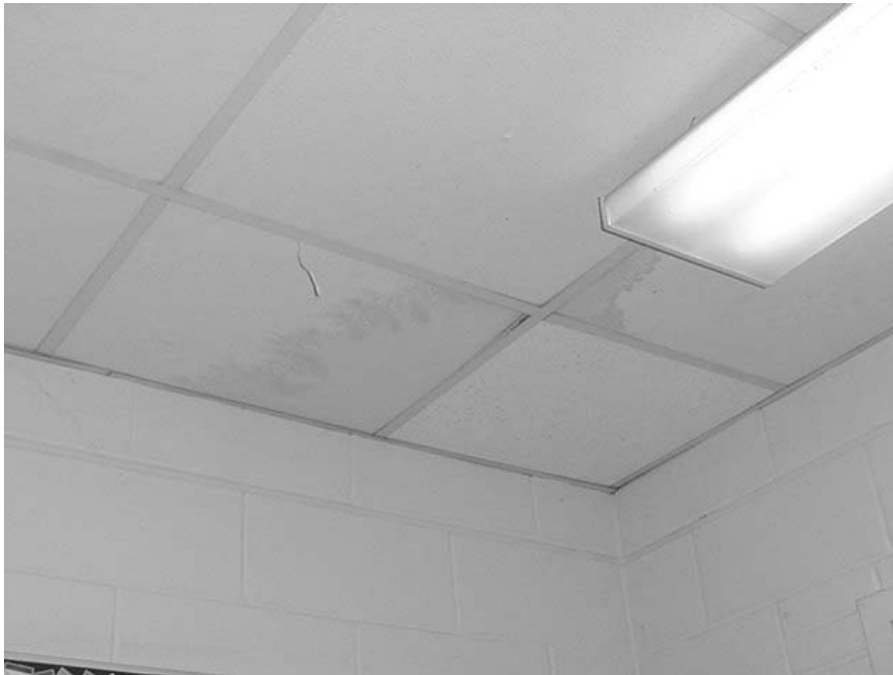
**Picture 6**

A number of rooms had water-stained ceiling tiles, which are an indication of leaks originating from the roof, skylight or pipe system (Picture 6 and 7). Water-damaged ceiling tiles can provide a source of mold growth. Water-damaged ceiling tiles should be replaced after a water leak is discovered and repaired. Appropriate measures should be taken to minimize the aerosolization of particulates from tile removal/replacement.

**Water-damaged ceiling tile (new wing)**

6. Identify and repair sources of water leaks (e.g., window frames and roof). Replace water-damaged ceiling tiles. Examine non-porous surfaces beneath ceiling tiles and disinfect with an appropriate antimicrobial.

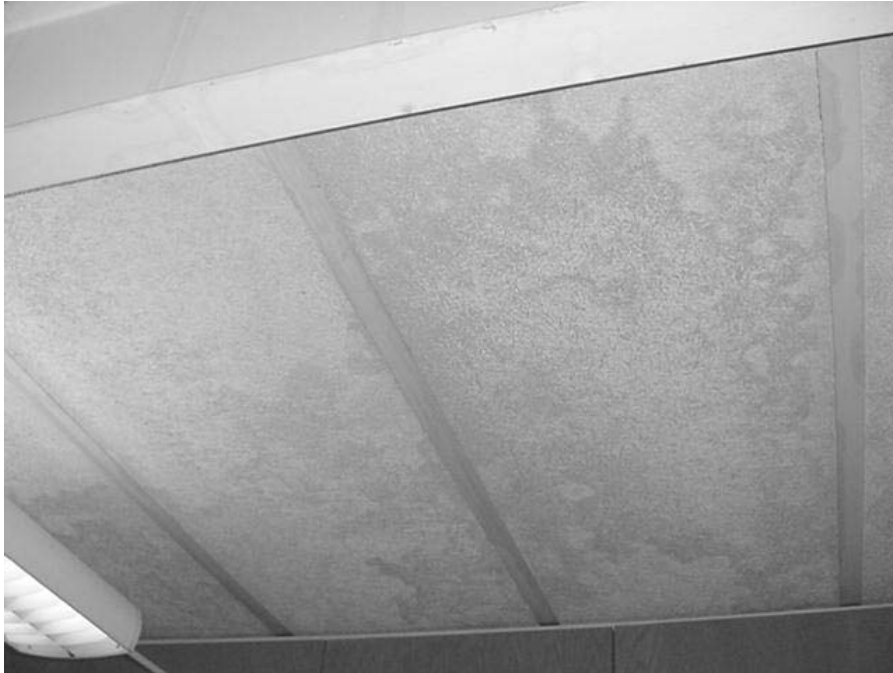
**Picture 7**

**Water-damaged ceiling tile (old wing)**

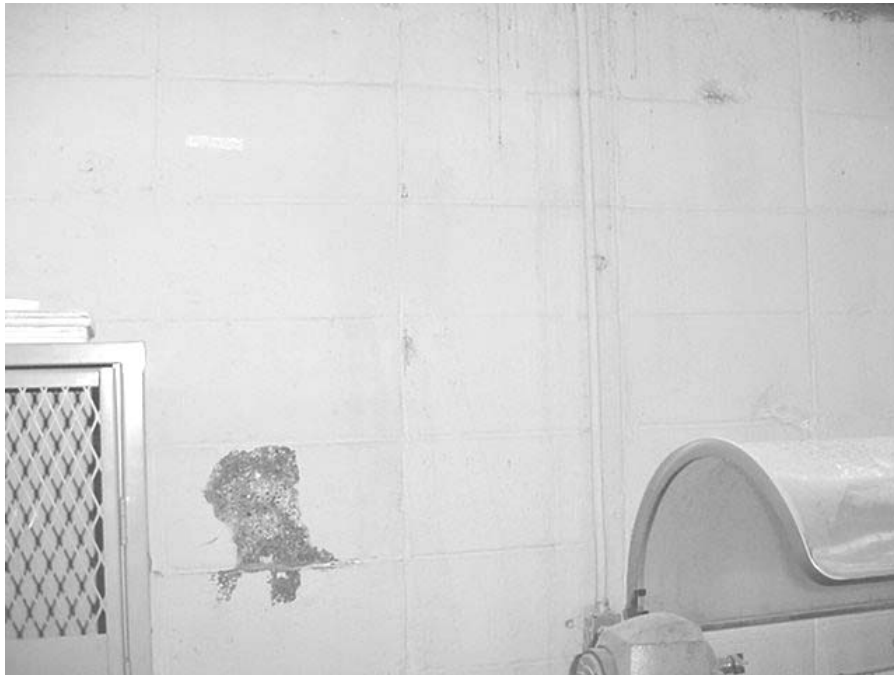
**Picture 8**

Signs of efflorescence and water intrusion were noted on cement walls in the wood shop area (Picture 8). Efflorescence is a characteristic sign of water damage to building materials such as cement or plaster, but it is not mold growth. As moisture penetrates and works its way through exterior wall, water-soluble compounds dissolve, creating a solution. As the solution moves to the surface of the interior wall, water evaporates, leaving behind white, powdery mineral deposits. This condition indicates that water from the exterior is penetrating the building.

**Efflorescence and signs of water intrusion**

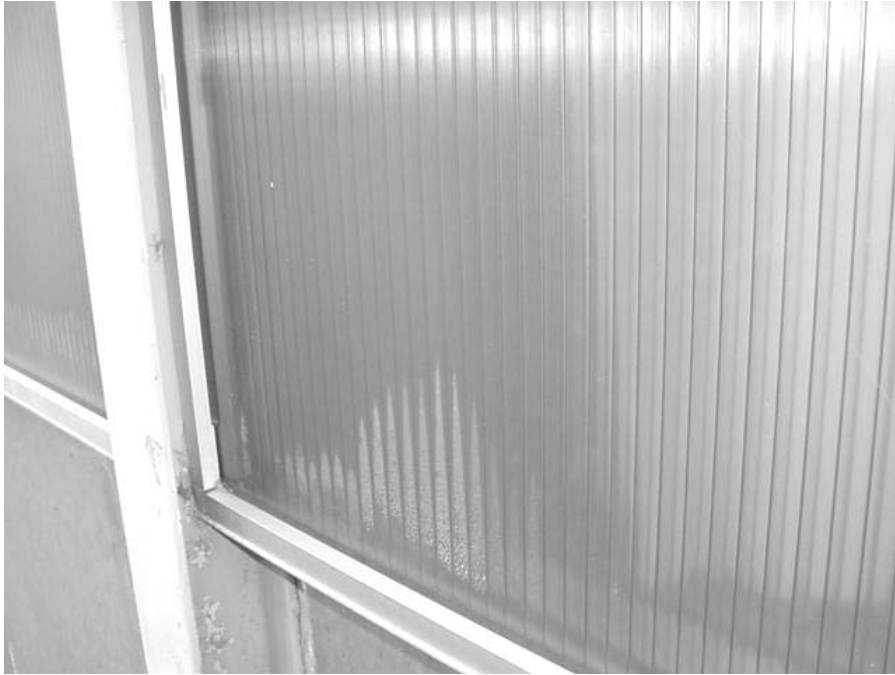
**Picture 9**

Portions of the MERMHS have windows constructed from ridged-plastic material. Condensation formation was noted in these windows (Picture 9). Upon closer inspection, breaches were noted in the exterior panel of the window (Picture 10) and portions of the window frame were missing (Picture 11). Water penetrating through the window can result in water damage to other building materials (Picture 12). Condensation accumulation between window panels may also result in microbial growth.

**Condensation between window panes**

1. Consider purchasing a standard metal-based chemical hood, equipped with localized exhaust.
2. Consider purchasing wet clay that does not require mixing. If clay must be mixed, wear proper NIOSH approved respiratory protection and/or conduct mixing under local exhaust ventilation or in a chemical hood (usually located in science areas).
3. Consider replacing window panels.

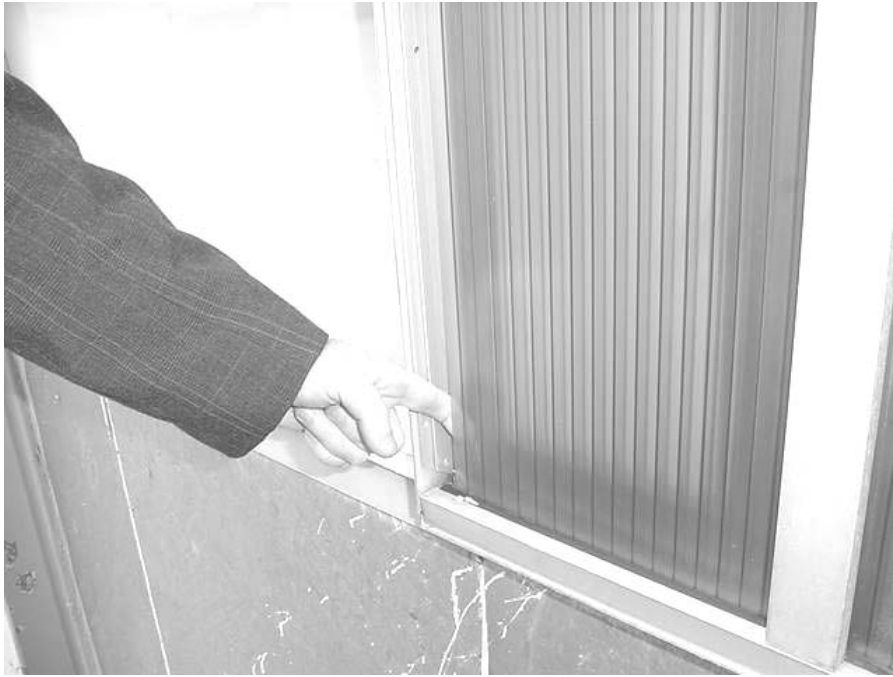
**Picture 10**

**Breach in window pane**

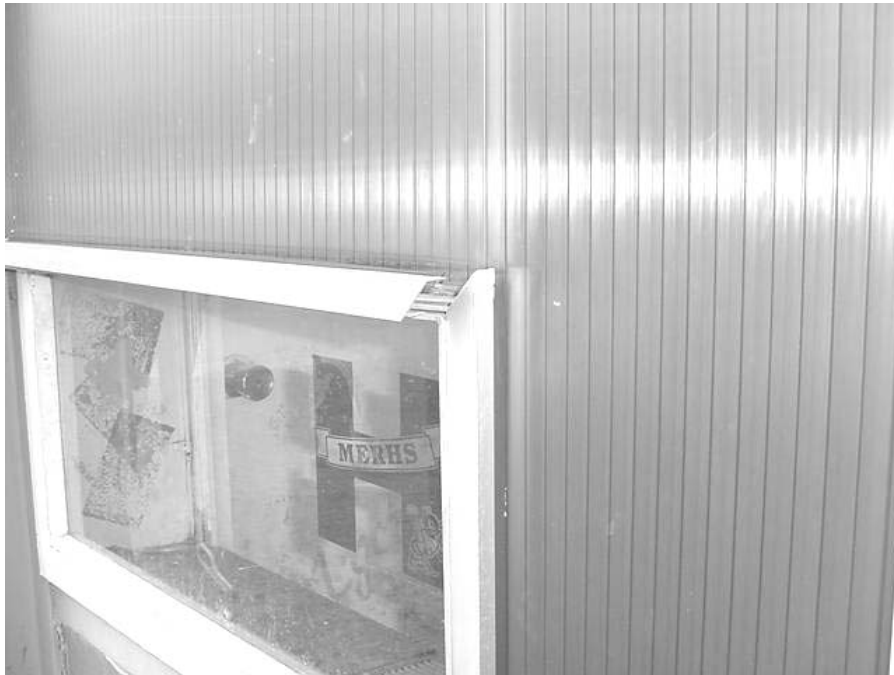
**Picture 11**

**Missing portion to window frame**

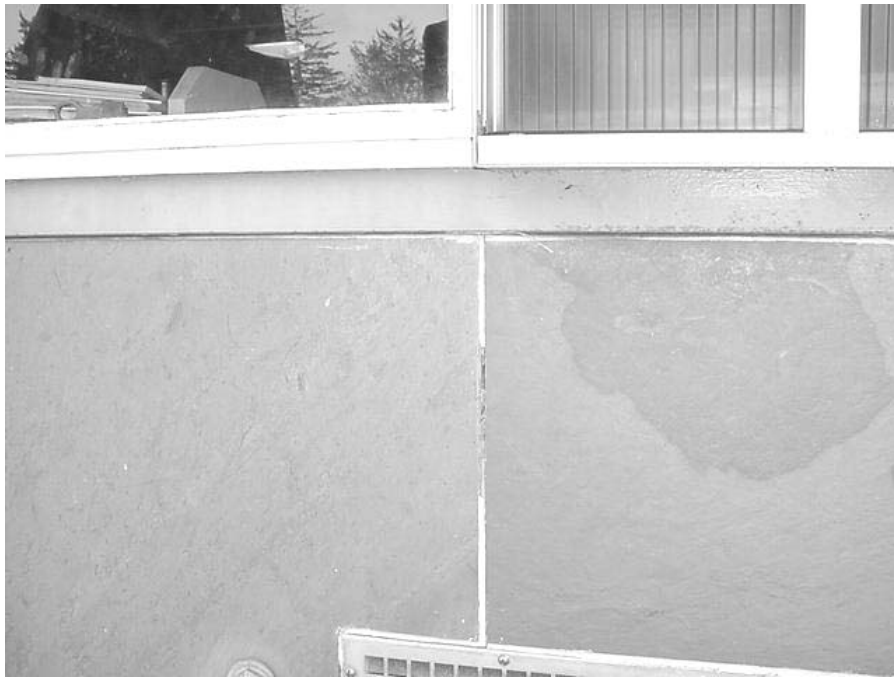
**Picture 12**

**Stained exterior wall material**

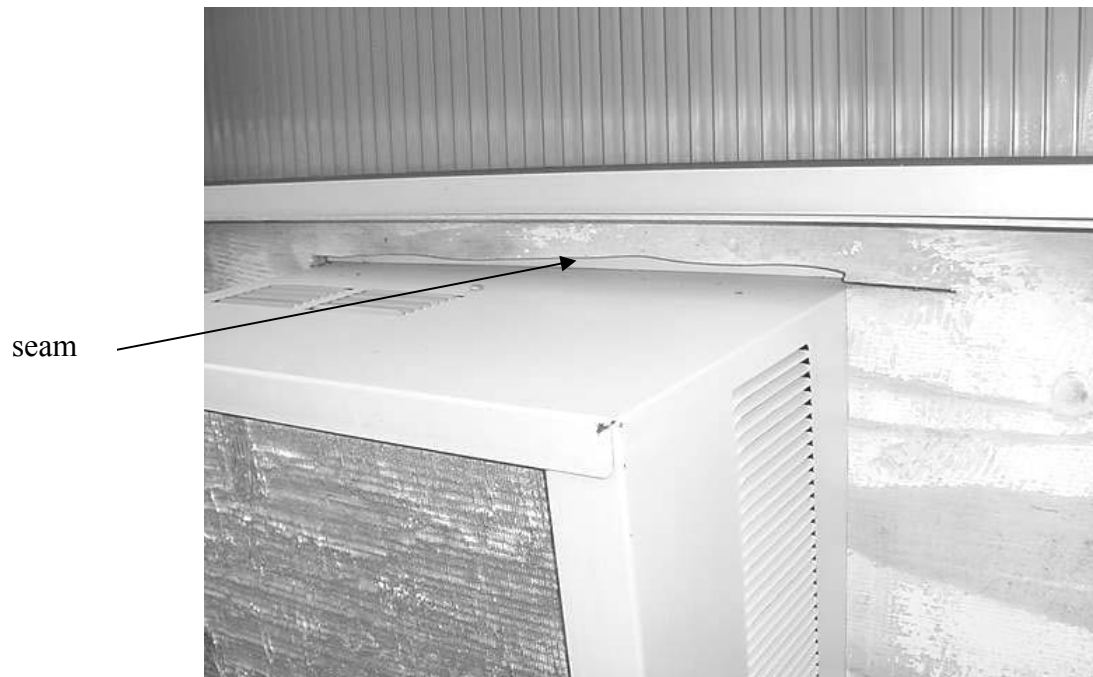
**Picture 13**

In addition, window-mounted air conditioners are installed in some areas. Wood is used to frame air conditioning units in the windows (Picture 13). Seams were noted between the wood frame and unit. Such seams can allow water to penetrate the building.

**Seam between wood frame and window-mounted air conditioning unit**

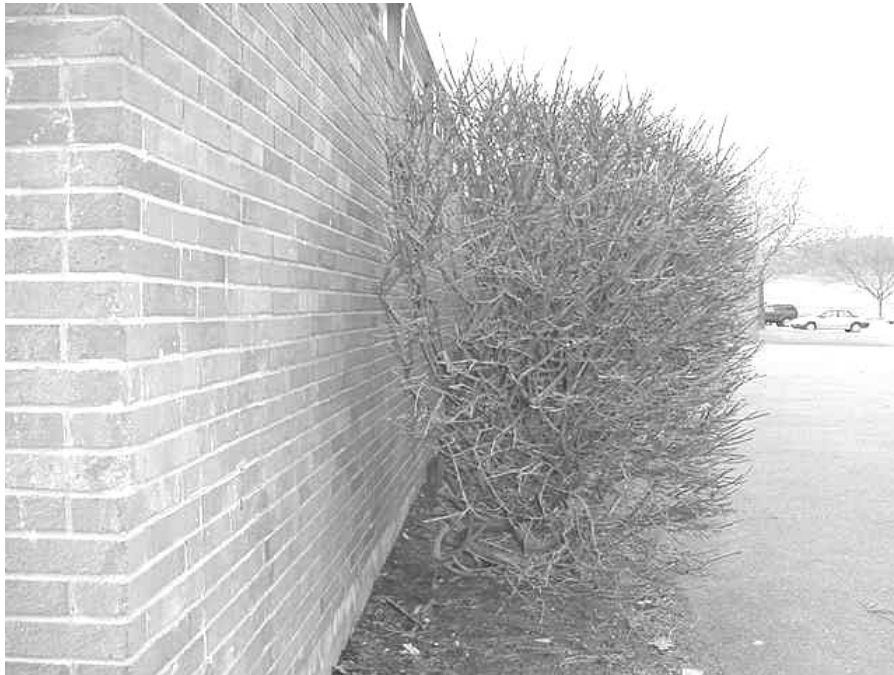
**Picture 14**

Plants and shrubs were also growing in close proximity to the MERMHS building (Picture 14). The growth of roots against the exterior walls can bring moisture in contact with wall brick. Plant roots can eventually penetrate the brick, leading to cracks and/or fissures in the foundation below ground level. Over time, this process can undermine the integrity of the building envelope, providing a means of water entry into the building through capillary action through foundation concrete and masonry (Lstiburek & Brennan, 2001).

**Shrubbery growing in close proximity to building**

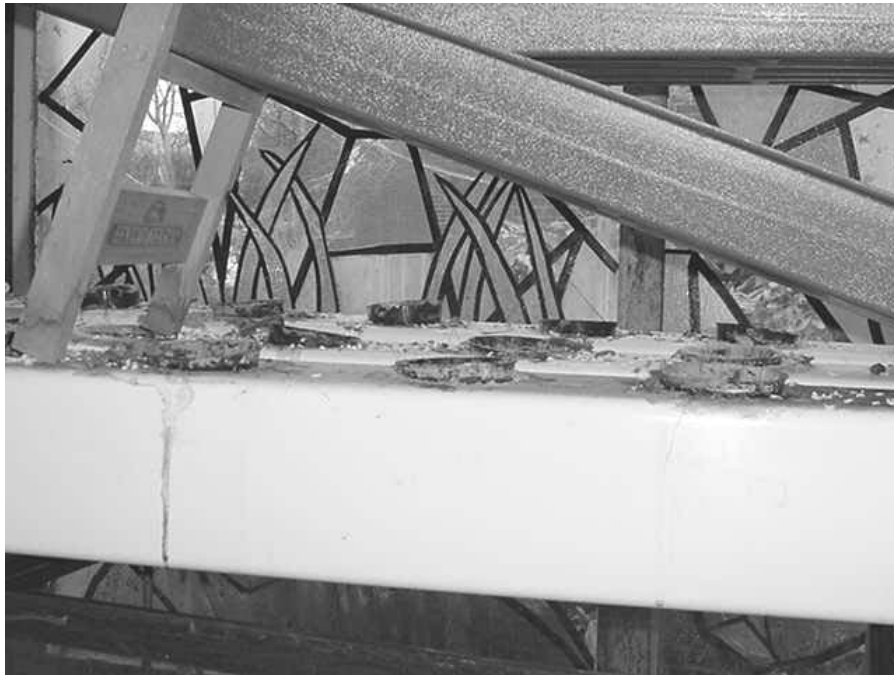
**Picture 15**

Plants were noted in several classrooms. In one science room, evidence of an apparatus once used for a plant project remained (Picture 15). Plants can be a source of pollen and mold, which can be respiratory irritants for some individuals. Water-damaged porous materials (e.g., paper) can serve as a source for mold growth (Picture 16). Plants should be properly maintained and equipped with drip pans. Plants should also be located away from univents and other ventilation sources (e.g. openable windows) to prevent aerosolization of dirt, pollen or mold.

**Decomposing plant material**

7. Examine plants in classrooms for mold growth in water catch basins. Disinfect water catch basins if necessary.
8. Relocate or consider reducing the amount of materials stored in classrooms to allow for more thorough cleaning of classrooms. Clean items regularly with a wet cloth or sponge to prevent excessive dust build-up.

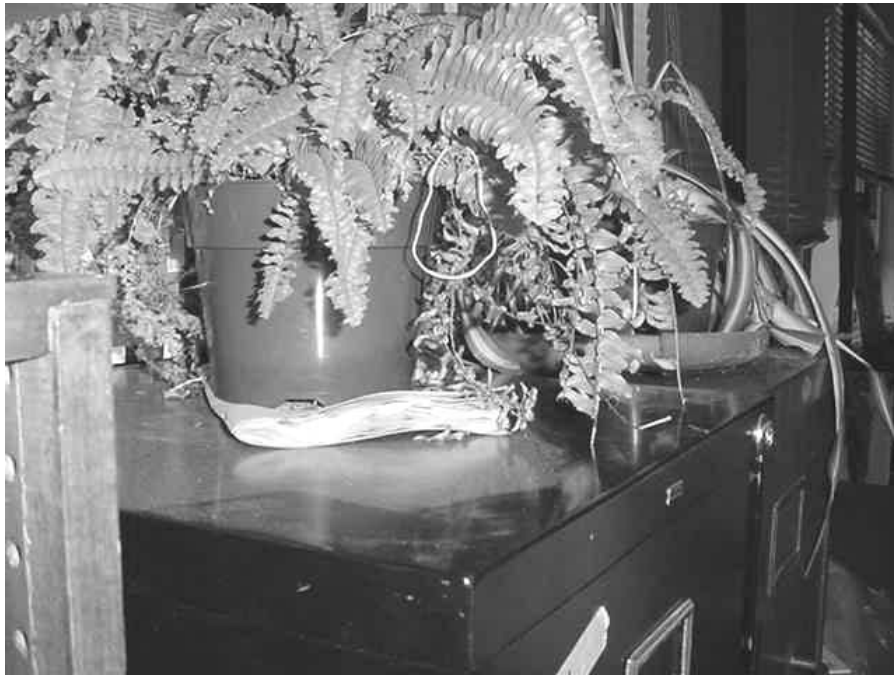
**Picture 16**

**Plant placed on paper materials**

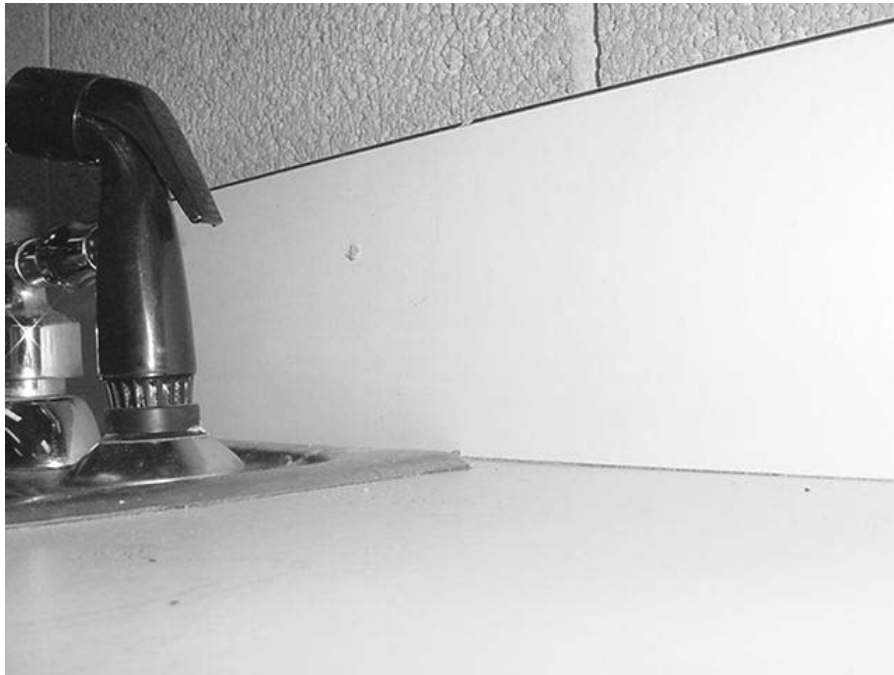
**Picture 17**

Other sources for water damage were also observed. Open seams between the sink countertop and wall were observed in several rooms (Picture 17). If not watertight, water can penetrate through the seam, causing damage. Water penetration and chronic exposure of porous and wood-based materials can cause these materials to swell and show signs of water damage.

**Breaches between countertop and backsplash**

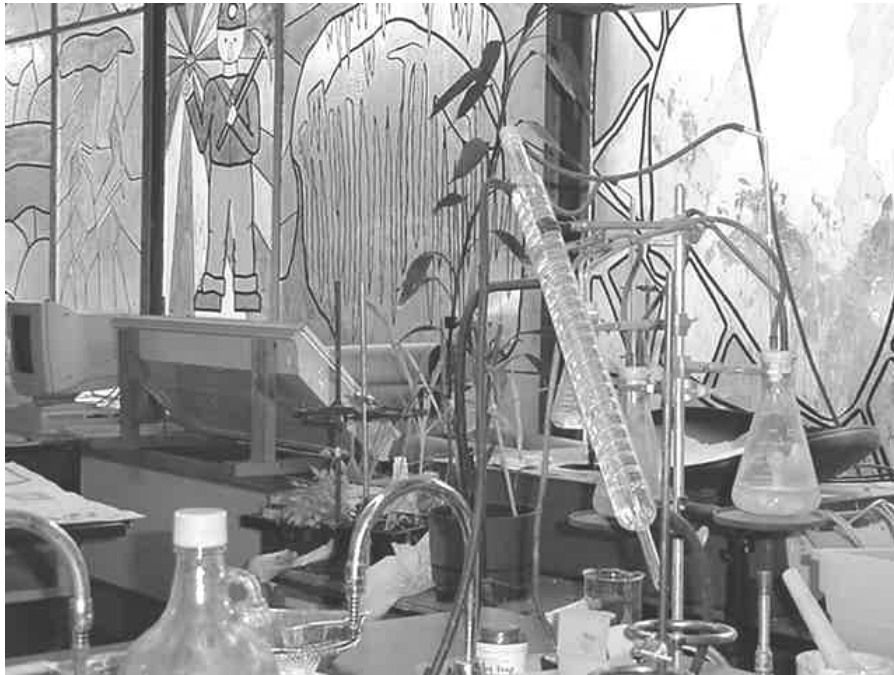
**Picture 18**

As discussed, the amount of materials stored inside classrooms, especially in classroom 9, is noteworthy. In classrooms throughout the school, items were seen on windowsills, tabletops, counters, bookcases and desks. The amount of items stored in classrooms provides a means for dusts, dirt and other potential respiratory irritants to accumulate and make it difficult for custodial staff to clean.

**Accumulated materials placed on lab workbenches**

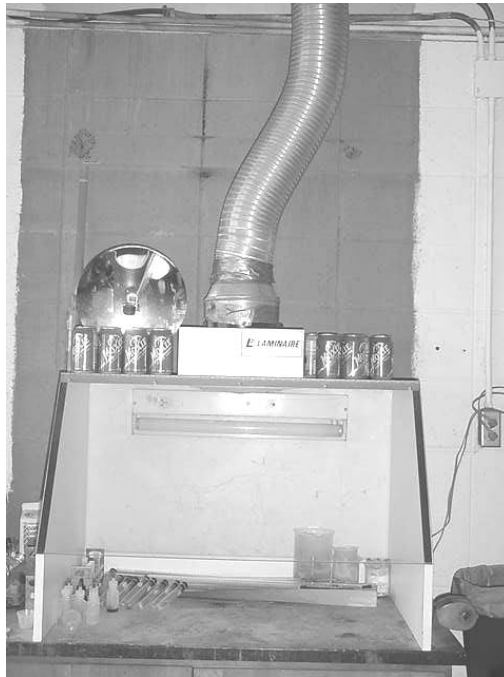
**Picture 20**

Of concern is the chemical hood in classroom 9 (Picture 19). Standard chemical hood units are constructed of metal sheeting. In contrast, this chemical hood is constructed of laminated particleboard. Over time, the laminate is prone to degradation (e.g. cracking, peeling). These breaches in the laminate allow odors and particles generated from chemicals and hood activities to penetrate the particleboard. Such odors and particles can also collect in the particleboard material. Use of ventilation hood exhaust can reduce odors and material accumulation. Even with adequate ventilation, odors, vapors and particles can still penetrate the particleboard.

**Chemical hood in Classroom 9 (March 10)**

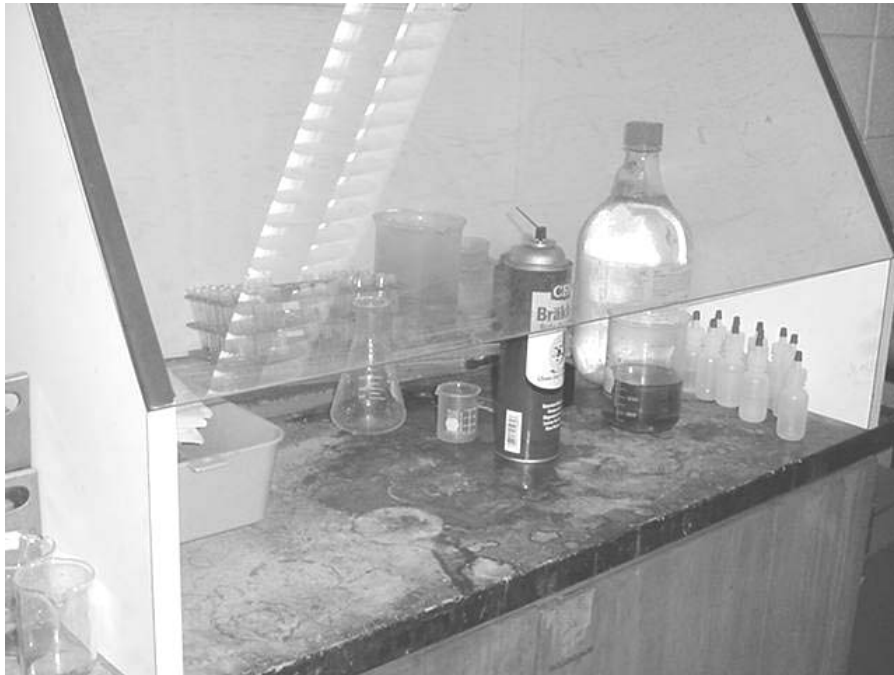
**Picture 21**

On the day of the April 14, 2004 assessment, BEHA staff observed materials stored in the chemical hood (Picture 20). The exhaust ventilation for the unit was not operating at the time. Exhaust ventilation for chemical hoods should be operational at all times to ensure vapors and odors off gassing from materials placed within chemical hoods are removed. Stock bottles and other chemical materials were also noted on laboratory benches (Picture 21). Chemicals should be returned to chemical storage areas once experiments have been completed.

**Chemical storage in hood**

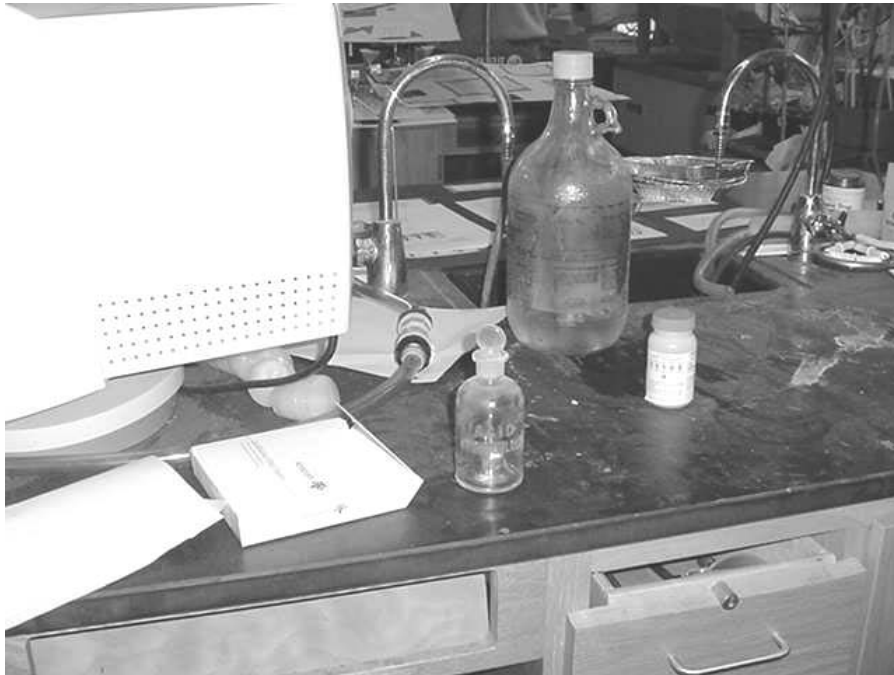
**Picture 22**

**Chemical storage on lab work benches**

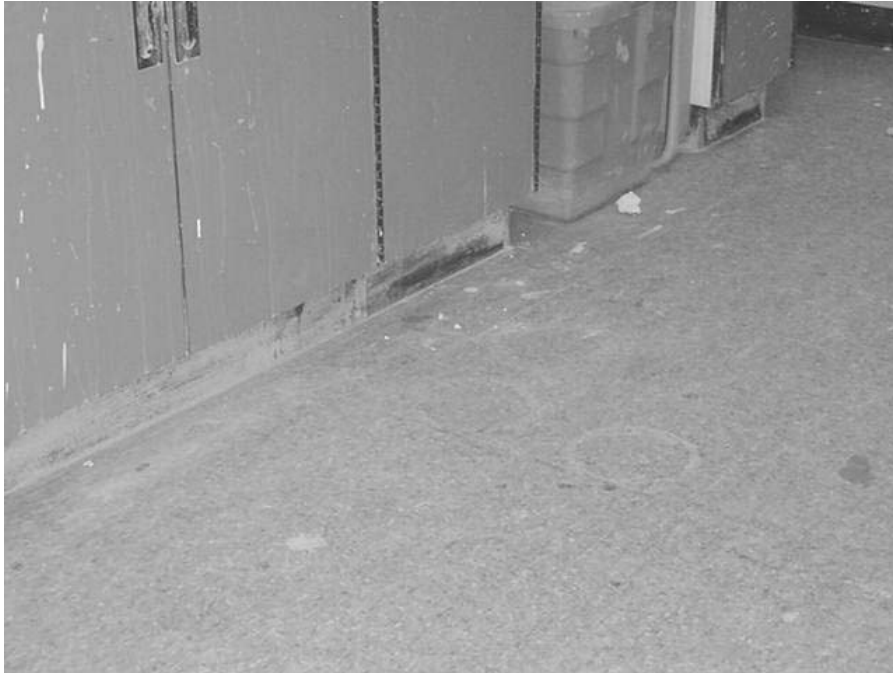
**Picture 23**

The floor and walls of the pottery side of the art room were coated with clay dust and residue (Picture 22). The most notable layers were located on and around pottery wheels (Picture 23). Clays contain silicates which can become easily aerosolized and serve as eye and respiratory irritants. The Center for Occupation Hazards, located in New York City, recommends avoiding all procedures that create dust (COH, 1979). Several measures to avoid the accumulation of clay dusts include wet mopping and wet wiping of horizontal surfaces (sweeping and dusting can stir up fine particulates) and use of a vacuum cleaner equipped with a high efficiency particulate arrestance (HEPA) filter to reduce the aerosolization of respirable dusts. Consideration should also be made towards purchasing wet clay that does not require mixing. If clay must be mixed, wear proper National Institute for Occupational Safety and Health (NIOSH) approved respiratory protection and/or conduct mixing under local exhaust ventilation or in a chemical hood (usually located in science areas).

**Clay dust on room fixtures**

9. Reduce clay dust accumulation by wet mopping and wet wiping horizontal surfaces. Use a vacuum cleaner equipped with a high efficiency particulate arrestance (HEPA) filter to reduce the aerosolization of respirable dusts.
10. Consider discontinuing use of the laminate particleboard based chemical hood.
11. Consider adopting the US EPA (2000b) document, Tools for Schools, in order to provide self-assessment and maintain a good indoor air quality environment at your building. The document can be downloaded from the Internet: <http://www.epa.gov/iaq/schools/index.html>.
12. Refer to resource manuals and other related indoor air quality documents for further building-wide evaluations and advice on maintaining public buildings. Copies of these materials are located on the MDPH's website:  
<http://www.state.ma.us/dph/beh/iaq/iaqhoFme.htm>.

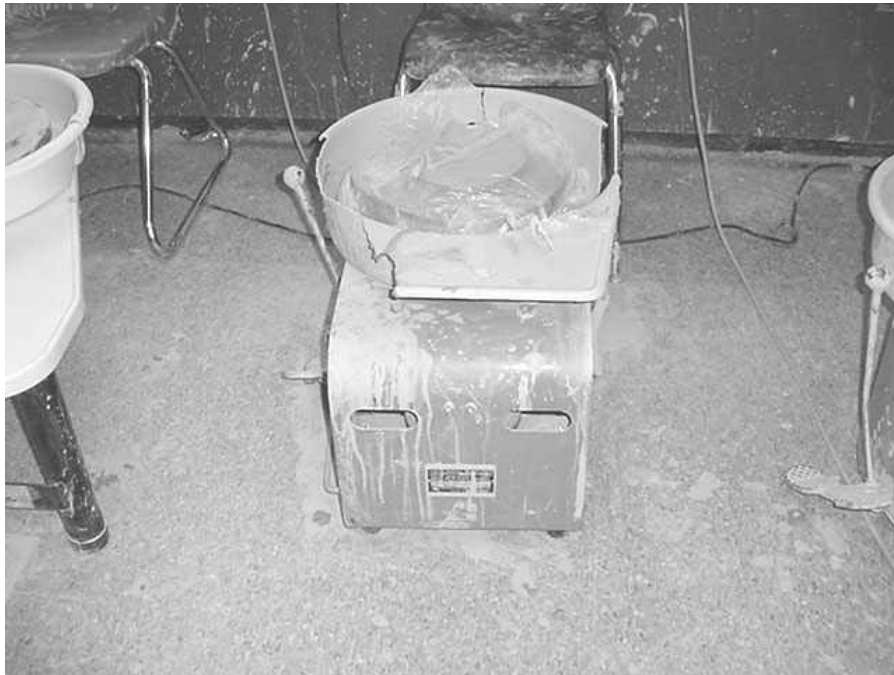
**Picture 24**

**Clay dust and materials around pottery wheel**

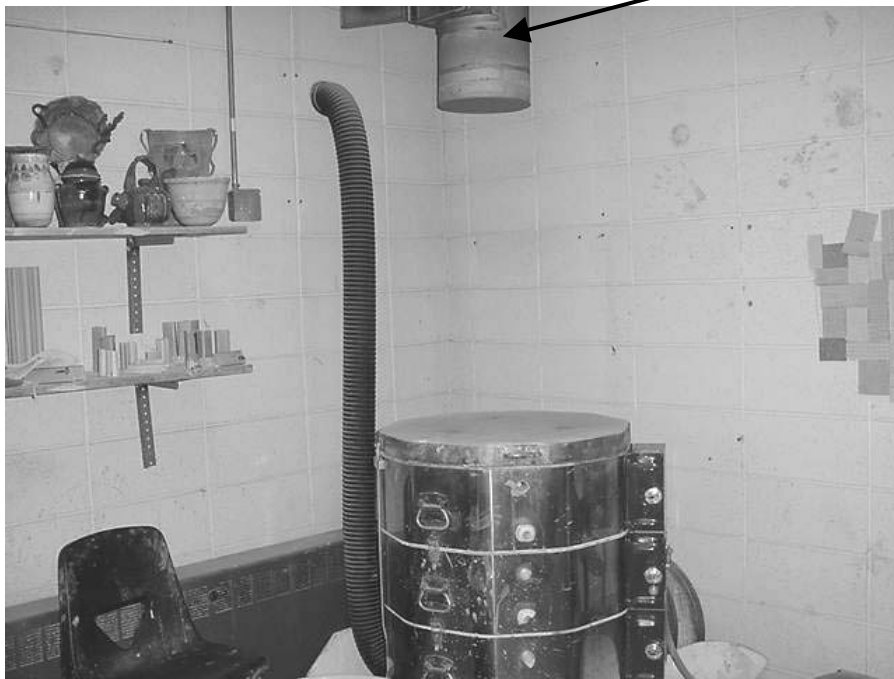
**Picture 25**

Currently, the kiln is fitted with an exhaust that removes exhausted materials outdoors (Picture 24). The exhaust vent is located on the exterior wall of the MERMHS (Picture 25). Above the kiln exhaust vent appears to be a disabled exhaust vent for a previously existing exhaust system. The previous system is still intact within the classroom (Picture 26). Under certain weather and wind conditions, materials exhausted from the functioning kiln exhaust may be forced into the deactivated exhaust system. As a result, materials removed from the kiln may penetrate into the pottery area and subsequently become aerosolized. To prevent distribution of kiln materials, the deactivated vent should be sealed.

Disabled kiln exhaust

**Kiln with attached exhaust, note previous exhaust system**

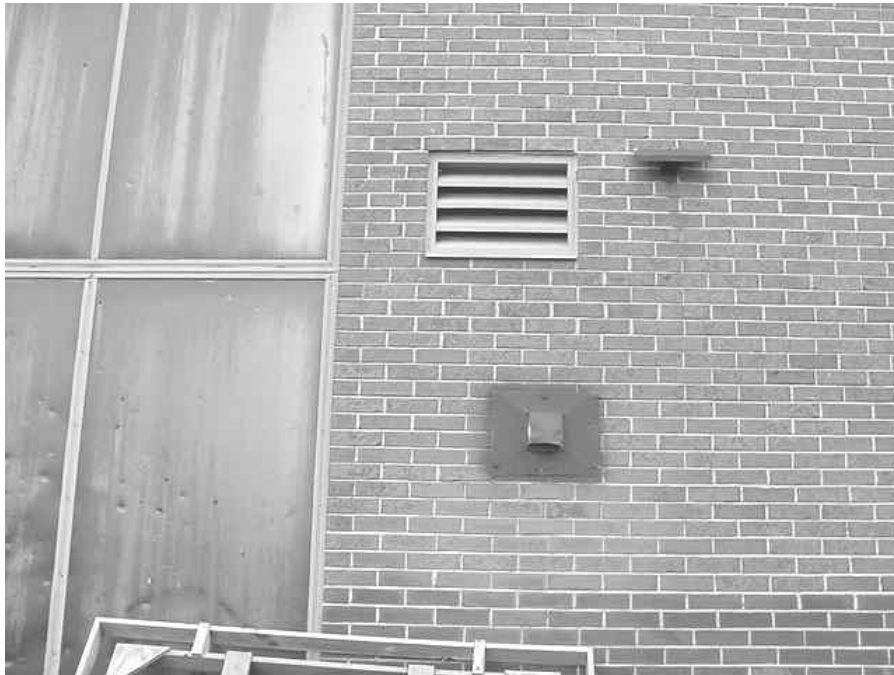
**Picture 26**

**Exhaust vent on exterior wall, note exhaust from previous system**

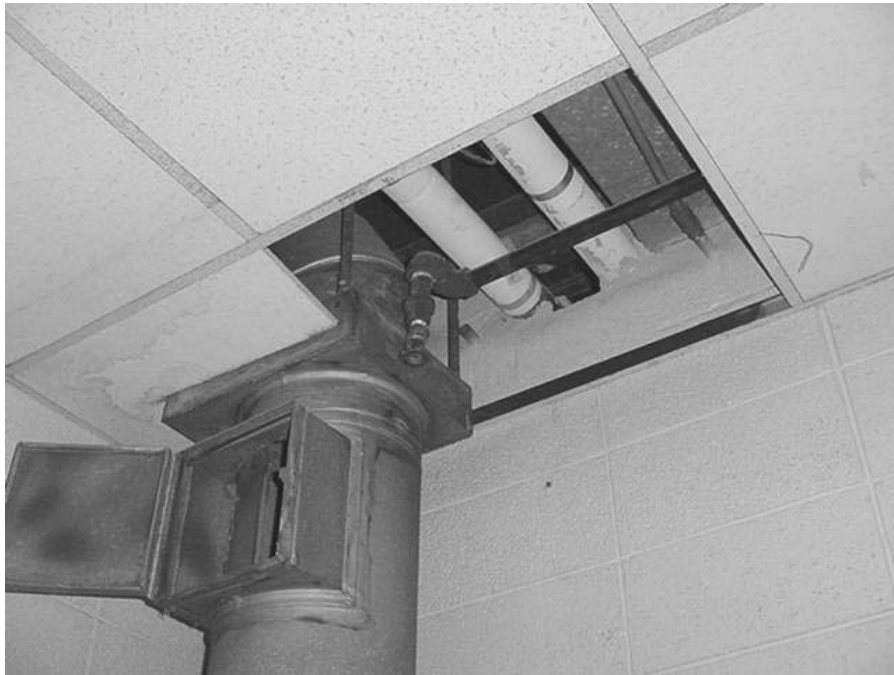
**Picture 27**

**Previous kiln exhaust system, note openned hatches**

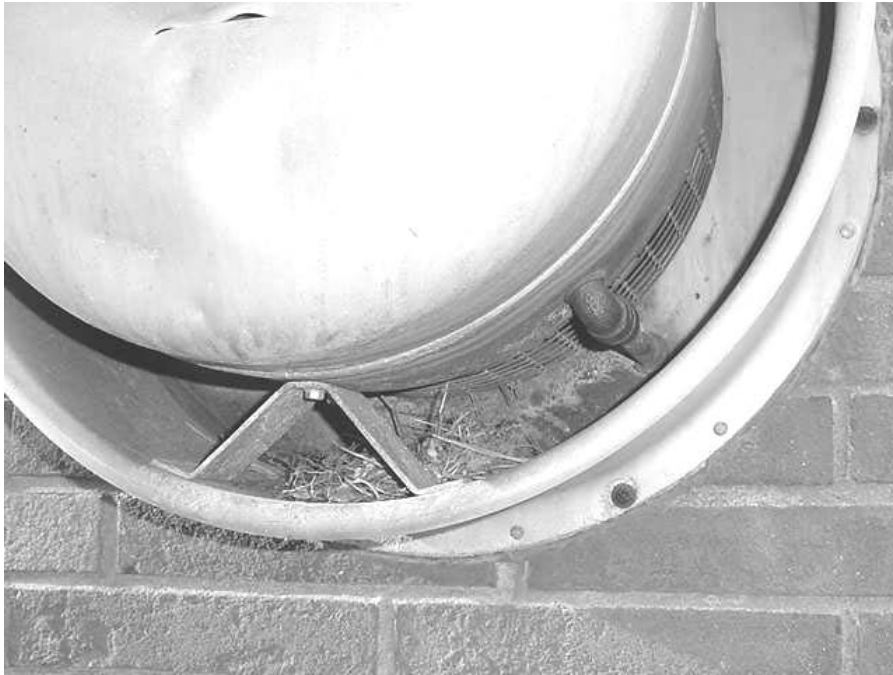
**Picture 28**

Lastly, during a perimeter inspection of the building, BEHA staff observed signs bird roosting and nesting materials in an exhaust fan on the exterior of the building (Picture 27). Birds can be a source of disease, and bird wastes and feathers can contain mold and mildew, which can be irritating to the respiratory system. No obvious signs of bird roosting inside the building were noted by BEHA staff nor were such signs reported by occupants. This nest should be removed to prevent entrainment of bird wastes. The purpose and function of the exhaust fan should be determined/assessed. If possible, consider sealing the exhaust fan to prevent bird roosting.

**Birds' nest in exhaust fan**
